The  
1928-1931  
Model A Ford  
Universal Joint Housing Caps—inner and outer  
And  
Transmission Main Shaft Bearing Retainer  
Assemblies  
By  
Steve C. Plucker  
as of  
October 13, 2006  
(Revision # 8)

The following study concerns the 1928-1931 Model A Ford Universal joint housing caps—inner and outer assemblies (and related parts) along with its counter part, the Transmission main shaft bearing retainer.

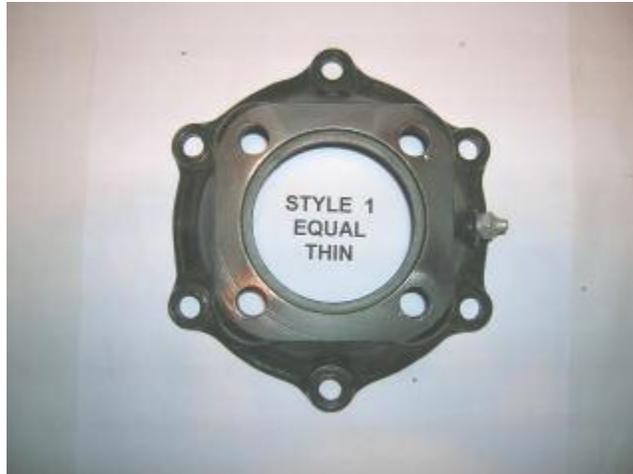
Fig. 1

The Transmission main shaft bearing retainer was represented by part number A-7085 and A-7085-A (Fig. 1). The six (6) bolt hole flanges were  $\frac{1}{4}$  inch in thickness and referred to as the **thin** type, it had a large center hole and raised “hump like” center areas on all four sides on the outside of the retainer. The grease zerk was on the middle right side of the retainer. These were stamped with the “Ford” script in various spots on the retainer. A good photo of its placement on the back of the transmission can be seen on page 236, Fig. 484 of the March, 1928 Ford Service Bulletin.

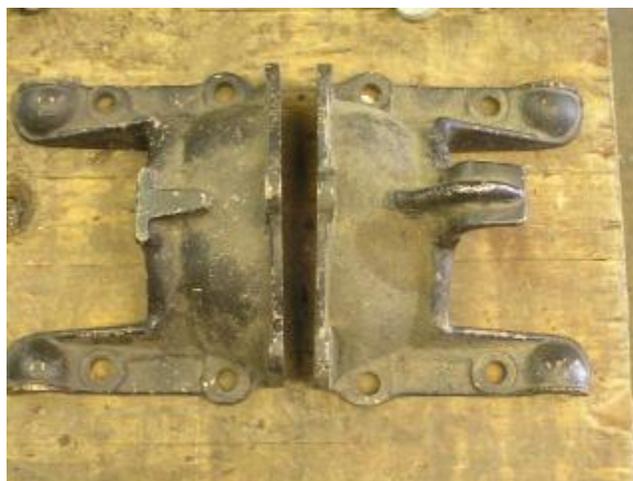
Fig. 2

The Universal joint housing cap—outer assembly, had no known individual part numbers at the time except as a complete assembly, A-4514-C. However to simplify things the upper half was known as A-4518 and the lower half was known as A-4514. There were two (2) known varieties of the “outer” assembly. Variety 1, (Fig. 2) has a safety lug with a raised, pronounced rib going up the center of the lug on the upper half. On the lower half there is a “T” type boss to position the safety lug which was to be welded on but was not. This variety has been confirmed on \*A189\*, owned by Mr. Charlie Bass, which was stamped on November 2, 1927. Variety 2, (Fig. 3) has the revised safety lug which was half round with no pronounced rib on the upper half. The lower half had a “D” shaped boss to position the safety lug which was to be welded on but was not. This variety has been confirmed on \*A1031\*, owned by Mr. Steve Ciccalone, which was stamped on December 1, 1927. It is not known when Variety 1 was discontinued or when Variety 2 began. The releases did not say.

Both halves had extension arms for the service brake equalizer brake system. Both varieties had 1/4 inch wide oil or grease grooves extending the length of the extended arms on the lower half only. The reinforcement ribs in the corners of the arms on Variety 2 were 1-1/16 inch in height, upper and lower, but were 1-3/16 inch in height on Variety 1 lower and unknown on the upper.

A good example of the lower part of Variety 1 can be found on page 222, Fig. 451 of the February, 1928 Ford Service Bulletin. If you have early copies of the Ford Parts Price List's, the pronounced “rib” can also be seen on the upper half of the outer housing, A-4520.

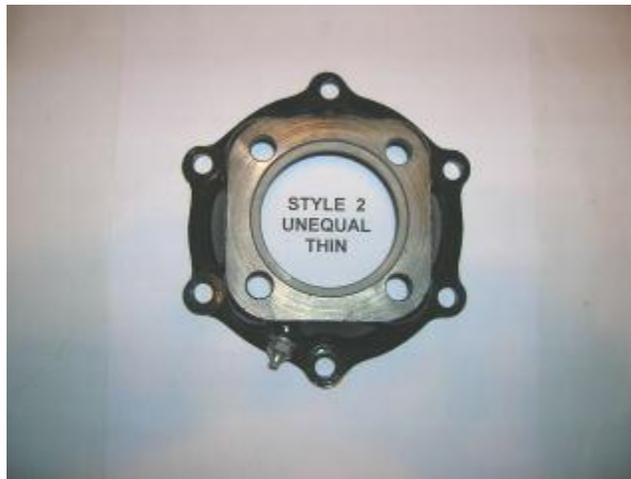
Fig. 4

The Transmission main shaft bearing retainer, represented by part number A-7085-B (Fig. 4), still had **thin** flanges, raised “hump like” center areas on all four sides of the retainer and still retained the large center hole. The only major change to this part was that the grease zerk was moved to the right 60 degrees to the bottom of the retainer where it remained throughout production. The “Ford” script is also on early styles of these retainers but was removed after late March, 1928 “for the convenience in exporting”!

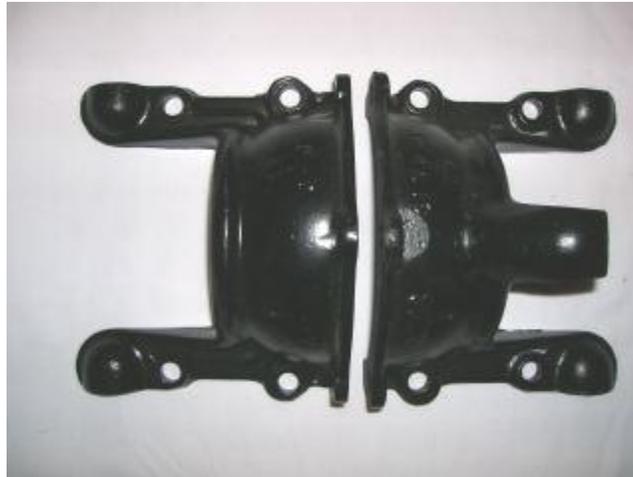
Fig. 5

The Universal joint housing cap—outer assembly, represented by part number A-4520 (Fig. 5), finally started to distinguish that the upper half of the assembly was A-4518 and the lower half was A-4514. The upper half, A-4518, still had the half round “D” shaped safety lug which was still being welded onto the part. The corner reinforcement ribs started out at 15/16 inches in height. However on December 30, 1927 they were reduced to 13/16 inches. The lower half, A-4514, also went through some changes. The “D” type boss, which was on Type 1, Variety 2, was removed. The reinforcement ribs changed in height from 1-1/16 inch to ¾ inch in mid December, 1927. Sometime between December, 1927 and February, 1928, the oil or grease grooves on the extended arms were changed from ¼ inch to 1/8 inch in width. However on February 13, 1928, the grooves were changed to 3/16 inch in width.

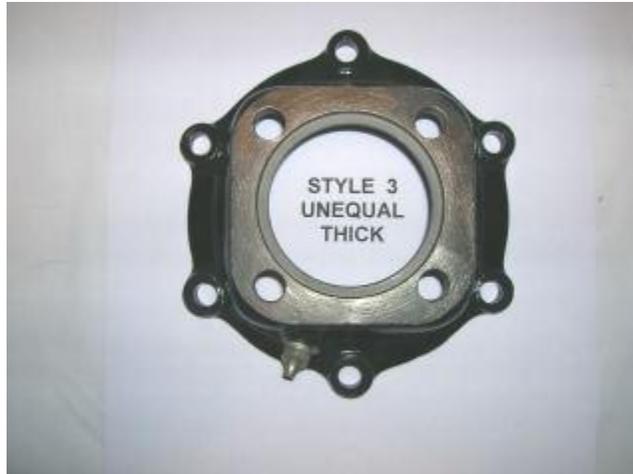
Fig. 6

The Transmission main shaft bearing retainer, represented by part number A-7085-C (Fig. 6), was a casting. However when it was redesigned, the six (6) bolt hole flanges changed from **thin** to **thick** and the four sides of the retainer were changed to flat, not “hump like” as with the two early styles. It still retained the large center hole and the grease zerk on the bottom of the retainer.

More than likely Ford changed the thickness of the six (6) bolt hole flanges on the Transmission main shaft bearing retainers due to the casting as they were not as strong as the forgings. At the start of production, the flanges were about  $\frac{1}{4}$  inch in **thickness**. By October, 1928, Ford went to **thicker** flanges which made them about  $\frac{5}{16}$  inch **thick**. An increase of  $\frac{1}{16}$  inch in **thickness** (Fig. 7). This also changed the bolt lengths which were used to connect the Universal joint housing caps—inner and outer by  $\frac{1}{16}$ <sup>th</sup> of an inch.

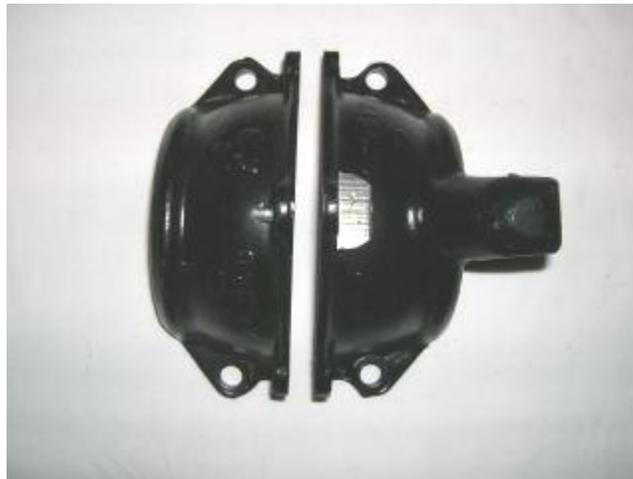
Fig. 8

The Universal joint housing cap—outer assembly (Fig. 8) was represented by part number A-4520-B. Both the upper and lower parts had the extended arms removed, as they were not needed for the new braking system. During the redesigning, both parts, whether forged or casting, had the thickness of the web between the bolt boss and the rear corner changed making it the same thickness as the boss. The edge between the bolt boss and the rear corner was also changed from being curved to being straight (Fig. 9). But may be found both ways. The upper half had three known part numbers, A-4518-B, which was a forging; A-4517-B1, unknown (have not viewed this part but may be a forging); and A-4517-B2, which was a casting or Malleable Iron Design. All three retained the safety lug. However with the “castings”, the lugs appeared to be formed with the part itself and not welded on as with the forgings. The lower half also had three known part numbers, A-4514-B, which was a forging; A-4514-B1, a forging (have not viewed this part); and A-4514-B2, which was a casting.

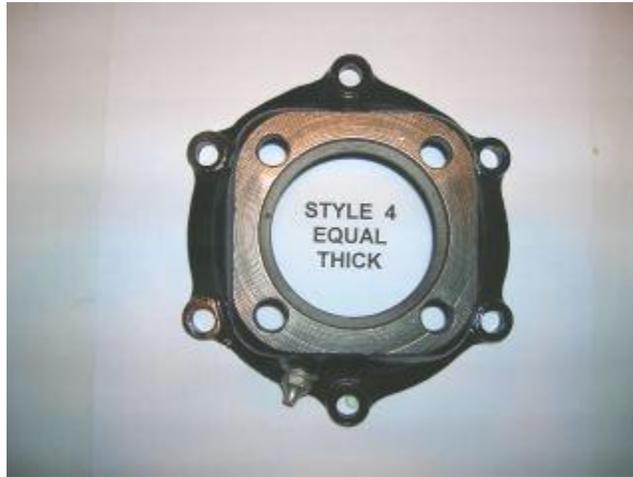
Fig. 10

The Transmission main shaft bearing retainer was represented by part number A-7085-A (Fig. 10). Some have A-7085-A1 stamped on them. It was identical to A-7085-C except it now had **equal** spaced holes. It retained the large center hole, **thick** flanges and it's construction was the Malleable Iron Design.

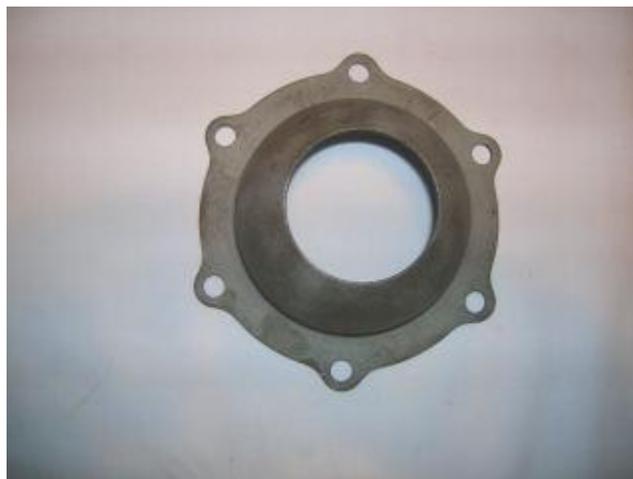
Fig. 11

The Universal joint housing cap—inner, reverted back to the original part number of A-4513-A (Fig. 11). In actuality it was the same as the first style but the only difference was that there were two 3/8 inch holes punched into the side of the bell portion for extra lubrication of the Universal Joint Assembly, A-7090. The large hole in the bell portion was 2-9/32 inch diameter and remained as such throughout production. Some inner later caps have been seen without the two 3/8 inch holes. Some inner earlier caps have the two 3/8 inch holes drilled on the side which the service department may have done due to the explanation in the June, 1929 Service Bulletin.

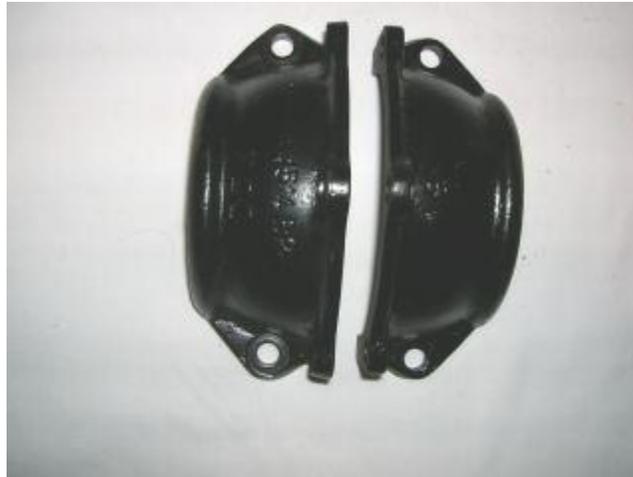
Fig. 12

The Universal joint housing cap—outer assembly, took on a new part number of A-4520-C. Ford had decided to remove the extension or safety lug on the upper universal joint housing cap thus “obsoleting” or discontinuing A-4518-B, A-4517-B1 and A-4517-B2 upper cap completely as “the lug is no longer necessary”. The upper cap was replaced with the lower cap, A-4514-B2 (Fig.12) which made the assembly **equal** spaced. It was explained in the June, 1929 Ford Service Bulletin that “This change eliminates the necessity of **unequally** spacing the bolt holes in both this part and its corresponding gaskets (not to mention the Universal joint housing cap—inner and the Transmission main shaft bearing retainer) as the **unequal** spacing was used simply to insure that the housing cap being assembled with the extension lug toward the top”. With the safety lug becoming obsolete on March 15, 1929, some upper halves of A-4518-B’s, which had been forged, may have just the “D” boss and not the safety lug.

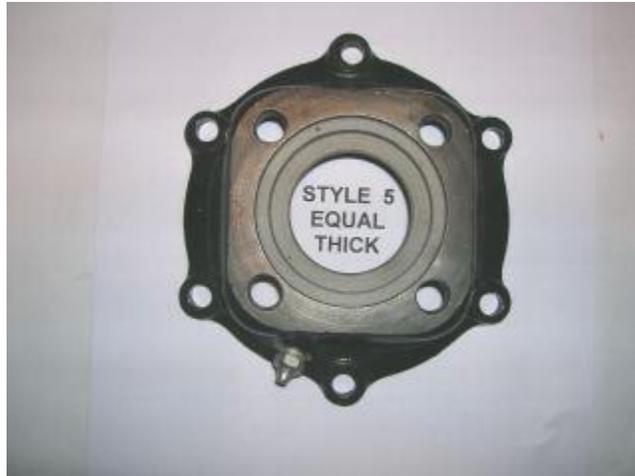
Fig. 13

This leads up to the final assembly, Type 5. The parts used in this assembly were the same exact parts as what was used in Type 4 assembly except for the new Transmission main shaft bearing retainer, A-7085-A1 (Fig. 13). Just when this retainer went into actual production is anybody's guess...any time from late June to September, 1929 and was continued in use through the production of the Model A Ford.

Type 4 assembly lasted but a few short months when on June 22, 1929, Release # 13297, Ford redesigned the Transmission main shaft bearing retainer. A flange was added to the large center hole which reduced it's size from 2-1/2 inches to 2-27/32 inches. It was finally reported in the September, 1929 Ford Service Bulletins about 100 days later and was done to “reduce any possibility of oil leakage through the rear transmission bearing”.
